Center of Excellence for Preservation  
and Service Life Extension

# Comparative Sustainability, LCA and Service Life Modeling for Repair vs. Rebuild – A Case Study

## A case study combines service-life analysis (SLA) and carbon footprint calculation

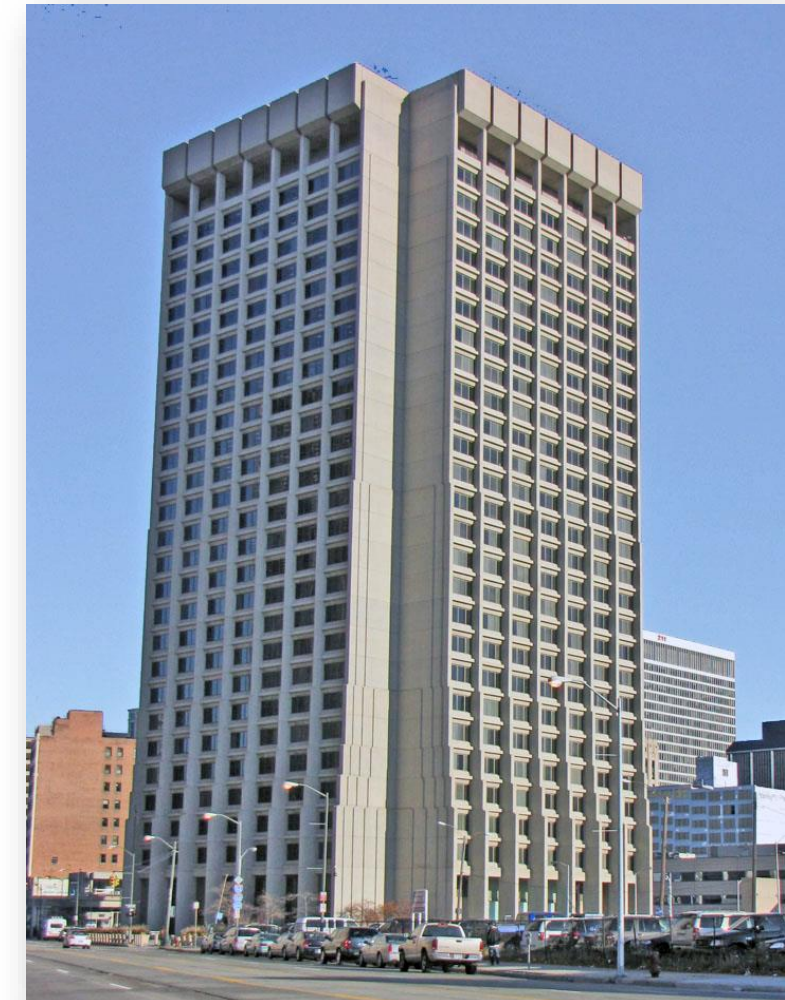
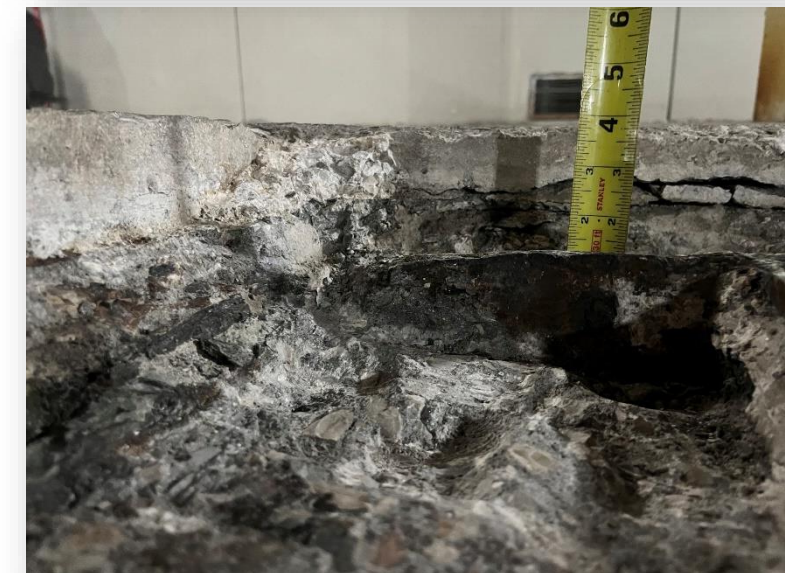
- + Patrick V. McNamara (PVM) federal building located in Detroit, MI
- + Built in 1973, this is an existing five-level reinforced concrete parking structure
  - 3 levels below grade (Levels 1-3),
  - 1 level at grade (Level 4), and 1 level above grade (Level 5).
- + Major concrete repair work is ongoing
- + Data from past inspections and reports were used.
- + Frequent exposure to deicing salt led to rebar corrosion.
- + Breakout windows showed extensive corrosion damage.
